# RESTORATION OF THE PONT TRENCAT

Barcelona. Spain.

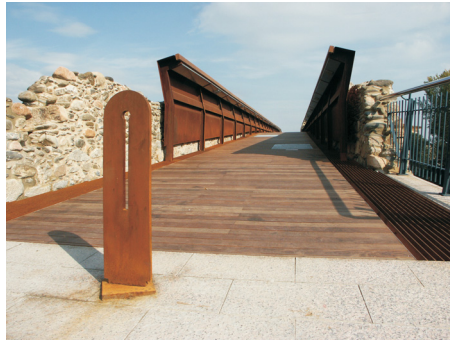
approach from the right bank

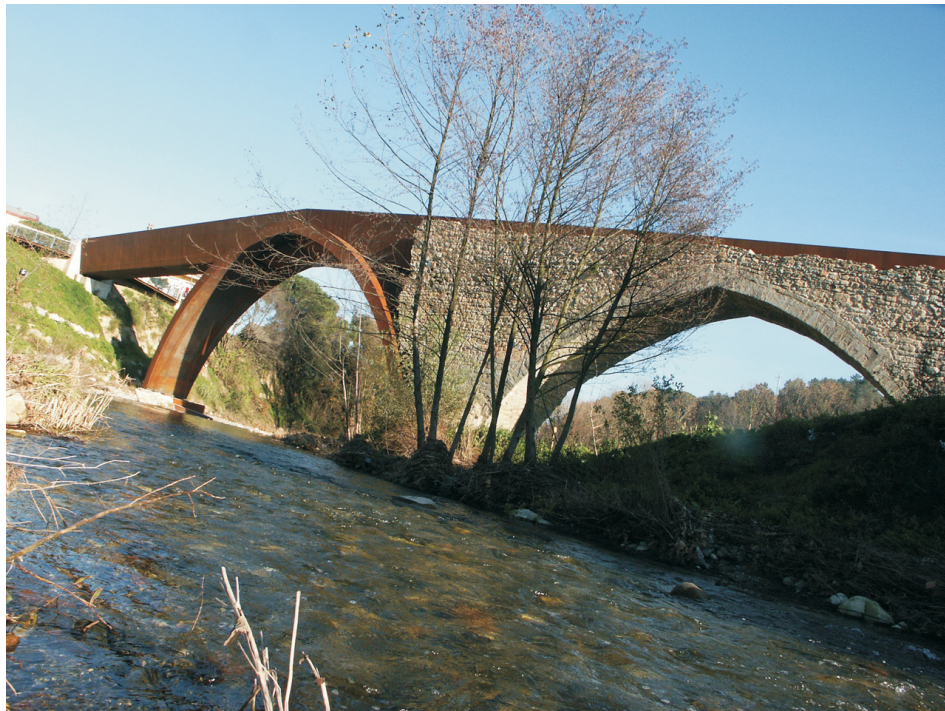
the remains in 1996

In 1811, during the Napoleonic Wars, the main arch of the "Pont Trecat" was destroyed. No one tried to repair it for almost one hundred and ninety years until 1996, when people from the two villages the bridge links, Sant Celoni and Santa Maria de Palautordera, situated fifty kilometers north-east of Barcelona, decided to raise funds to carry out its restoration.

Archaeological works and documentary research were first commissioned to obtain the information available about the history and the construction sequence of the bridge. Remains of the disappeared arch were found as well as part of the old pavement on both banks. Despite it is said to be a Roman bridge —it is placed on the Roman Via Augustea— we didn't find any remains of that time. We are not sure when the existing part was constructed but documents were found showing that in 1453 important works were made. It is quite likely that the current shape, with its pointed arch, dates from then.

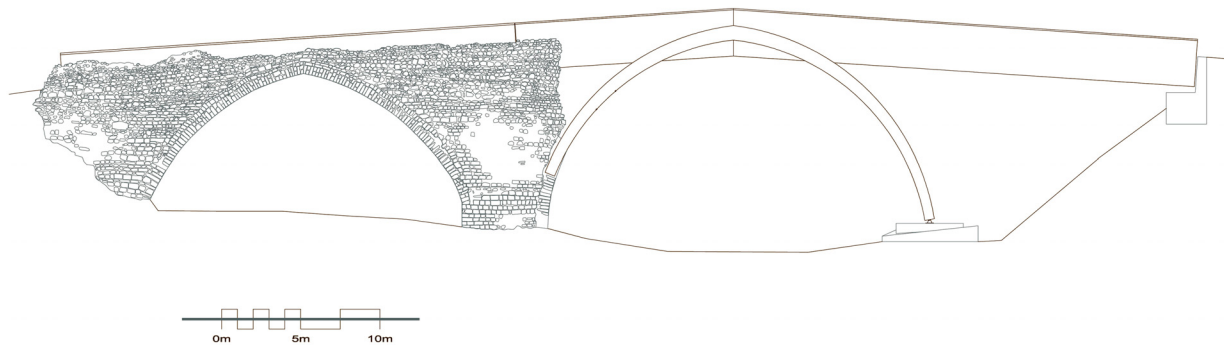
east plan elevation

The structure we constructed consists of a two span box girder deck, 3.00 meters in depth, supported by three pairs of bearings, two at both ends and the intermediate one placed over the crown of a hollow box pointed arch, spanning 24 meters. To emphasize the old silhouette, the parapets of the deck are extended along the remaining structure. The top line of the new deck and the intrados of the steel arch follow the shape we think the old bridge had so the new structure tries to evoke the missing silhouette of the original bridge.

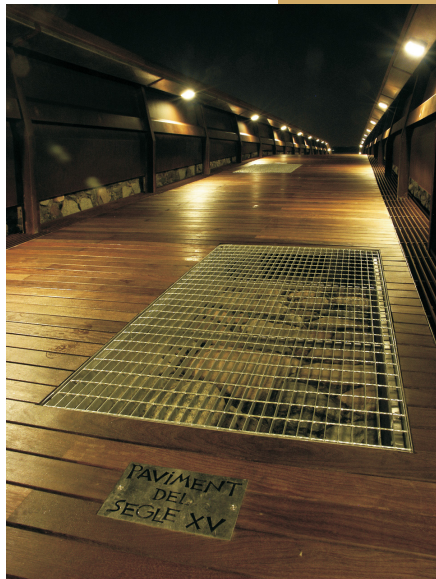
street lighting and pavement

In the third phase the pavement was made. Over the bridge we choose a timber pavement in order to provide pedestrians a warmer and more tactile material in contrast with the coldness of the steel. On both approaches the pavement was a combination made of rosé granite stone and washed concrete pieces. The street lighting over the bridge was placed into the parapets of the deck. On the ends, on each side, we installed some modern lampposts. The monumental lighting was placed on the lateral slopes, over the maximum flood level.

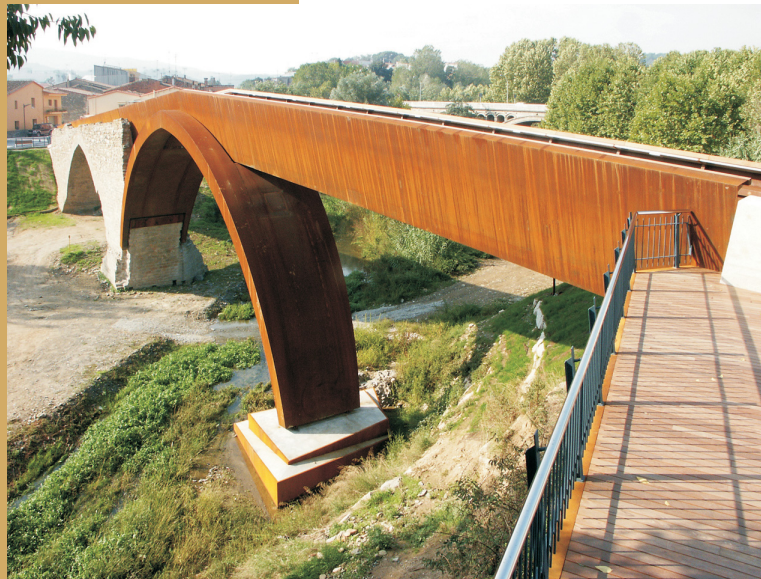
east view
